## RECONSTRUCTION OF NATURAL SLOPE STABILITY BY LIMIT EQUILIBRIUM METHODS AND FINITE ELEMENT METHODS

Andesta Granitio Irwan<sup>1\*</sup>, Irene Tresna Wiati<sup>2</sup>

<sup>1,2</sup>Civil Engineering Departement, Sains and Tech Faculty,  
Muhammadiyah Bangka Belitung University

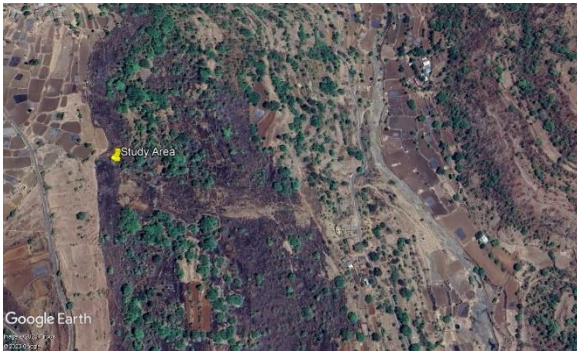
Figure 1. Location of topographic features of study location (Mod. Shah *et al.*, 2021)

Figure 1 above is a photo of the location taken using Google Earth aerial photos with updated photos for 2022 where in general the landslide area is still visible. The initial landslide in the study (Shah *et al.*, 2021) occurred in 2014 and was then analyzed using a cross-section in the landslide area which produced the appearance of the layers making up the slope as in Figure 2 below.

This study conducts a safety factor reconstruction for natural slopes on a hill, utilizing a case study conducted by (Shah *et al.*, 2021). The research focuses on a slope in Malingaon Village, India, where a landslide occurred along a 512 m stretch from the crest to the toe. The slope's coordinates are 19°9'46.78" N and 73°41'7.94" E, illustrated in Figure 1 below.

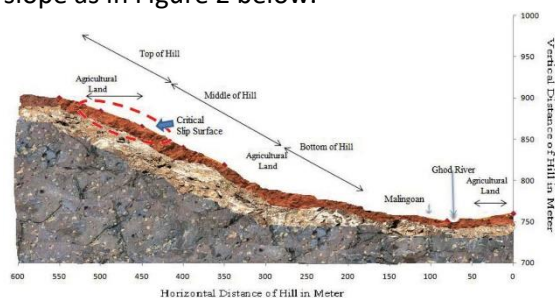
Figure 2. Cross-section study area (Shah *et al.*, 2021)

Figure 2 shows that there were three sampling zones after the landslide occurred, namely the top of Sandy-Clay, the middle of Silty Clay and the bottom of Clayey Loam. From the cross-section above, a slope stability analysis was carried out using the safety factor value for infinite slopes manually and the safety factor value was 0.5. In previous studies, it was explained that landslides occurred due to high rainfall at the research location, causing the condition of the slope material to be saturated with water, so it was necessary to analyze the saturated conditions in determining slope stability.

This study employed secondary data derived from geotechnical laboratory tests and slope geometry in prior research conducted by (Shah *et al.*, 2021). Slope reconstruction involved digitizing the geometry depicted in Figure 2 using AutoCAD 2021 software, with a focus on delineating the previously mentioned three zones. Subsequently, the digitized slope geometry underwent analysis using the Limit Equilibrium Method (LEM) and Finite Element Method (FEM) to derive safety factor results. These methods assume that the soil properties conform to the Mohr-Coulomb criterion, specifically as a perfectly plastic material. (Sengani and Allopi, 2022). The results of digitizing slope geometry can be seen in Figure 3 below.
