## **Lahar at Kali Konto after the 2014 Eruption of Kelud Volcano, East Java: Impacts and Risk**

Five days after the Kelud Volcano eruption of 13 February 2014, lahar occurred in several channels of the Volcano. Rainfall with intensity of 26 mm/hour mobilized pyroclastic material from the upper slopes of Kelud Volcano down the channel during 3.5 hour. Using this eruption as a case study, the aims of this paper are (1) to study the geomorphic impact of lahars and (2) to study future hazards and risks due to the potential of lahar source material and lahar repose area. To reach these two goals, we use both primary and secondary data. The primary data comprises an integration of remote sensing, GIS approach, and fieldwork control, in order to investigate the geomorphic impacts of lahars. Secondary data were collected through interviews and statistical approach in villages, in order to determine their perception to the risk of lahar. Morphogenic processes such as riverbank erosion, channel-widening and riverbed downcutting took an important role in generating the impact of lahar in Kali Konto. The medial and distal areas were affected more largely than the proximal area. This major im

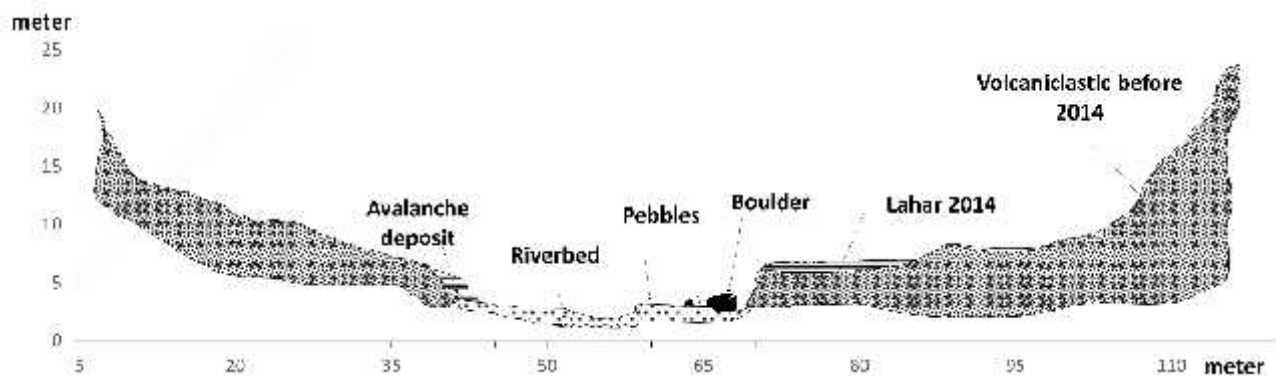
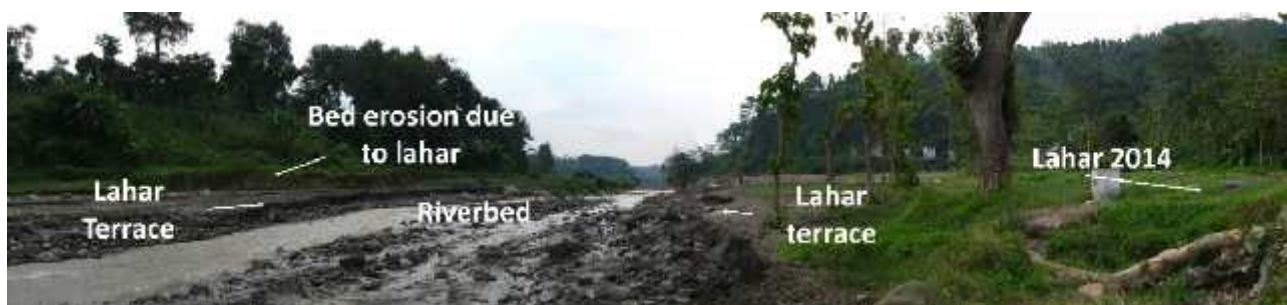
tentially damaged on the future lahar due to the pattern of river widening and lahar over flow or avulsion. The depth of the lahar reached 0.3 m to 1.2 m and damaged 2.3 ha crop field (Fig. 4). Crop field was buried by lahar with fine sand up to pebbles material.

**Figure 4.** Cross-sectional the proximal slope at Mendalan site\_(Yellow mark in Fig. 3)

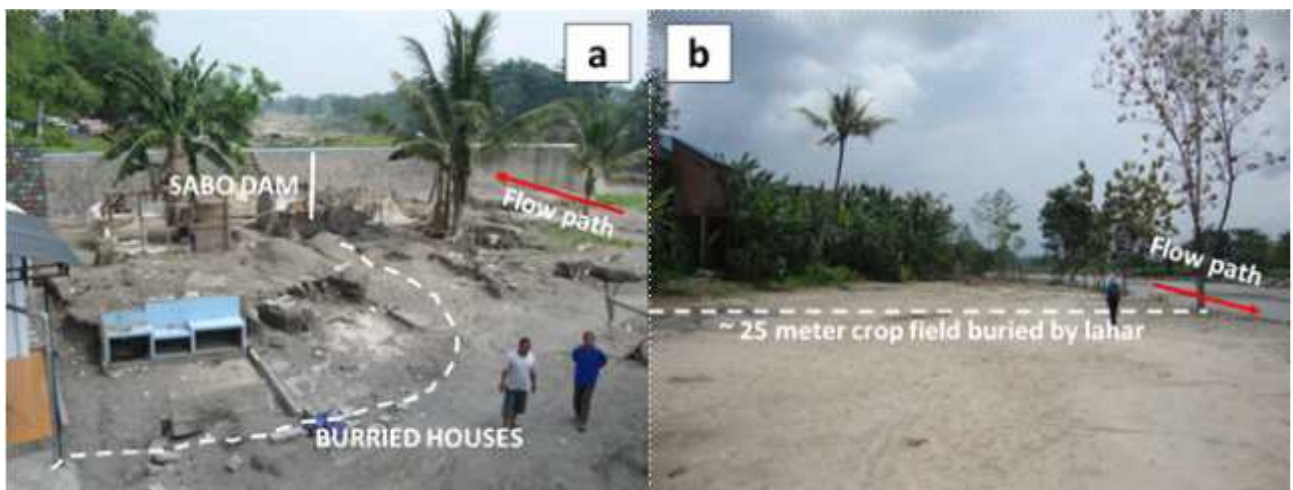
Contrary to the proximal slope, the medial slope of Kali Konto in Damarwulan, Kandangan more wide-spread than proximal slope. Impact of lahar in Damarwulan indicated by 6 houses and 1 mosque that located in the river bank was buried by lahar (Fig.6). This houses are illegal house due to land owned by irrigation division of Public Work Department. This lahar potentially damage the settlement that located 30 m near the maximum lahar corridors. Lahar created ~60

**Figure 6.** (a) The houses and mosque that damage due to lahar and (Red Mark in Fig.5) (b) crop field located in eastward of river channel covered by lahar (Yellow mark in Fig. 5)

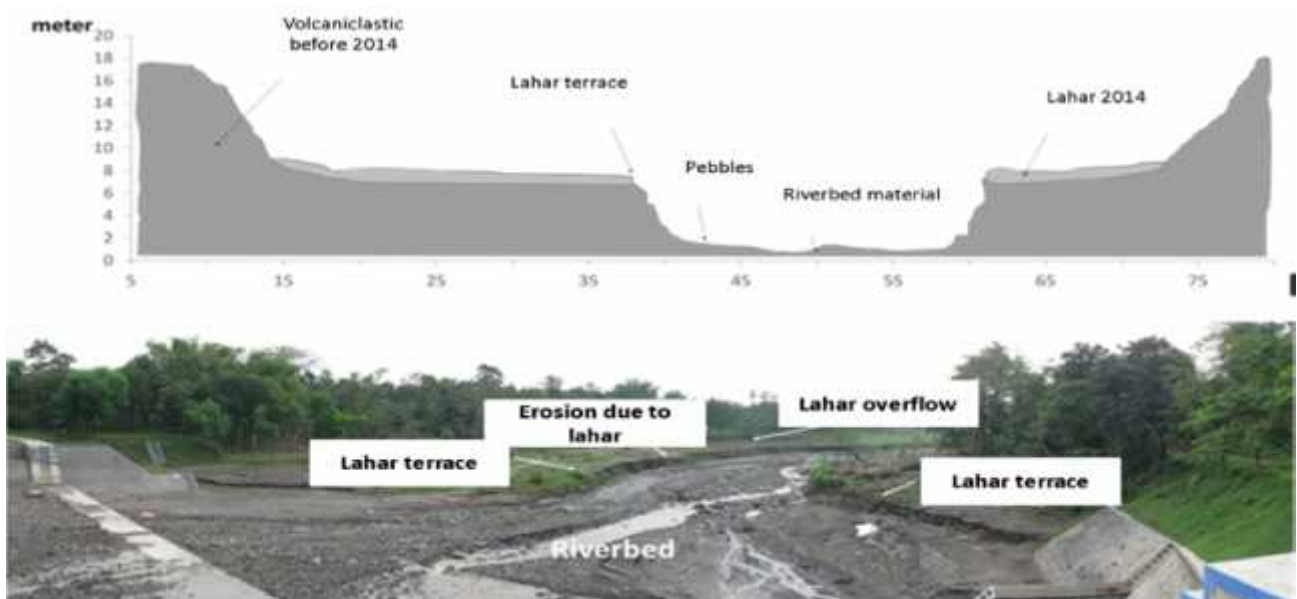
**Figure 7.** Cross-sectional on the medial slope at Kandangan site (Red mark in Fig. 5)

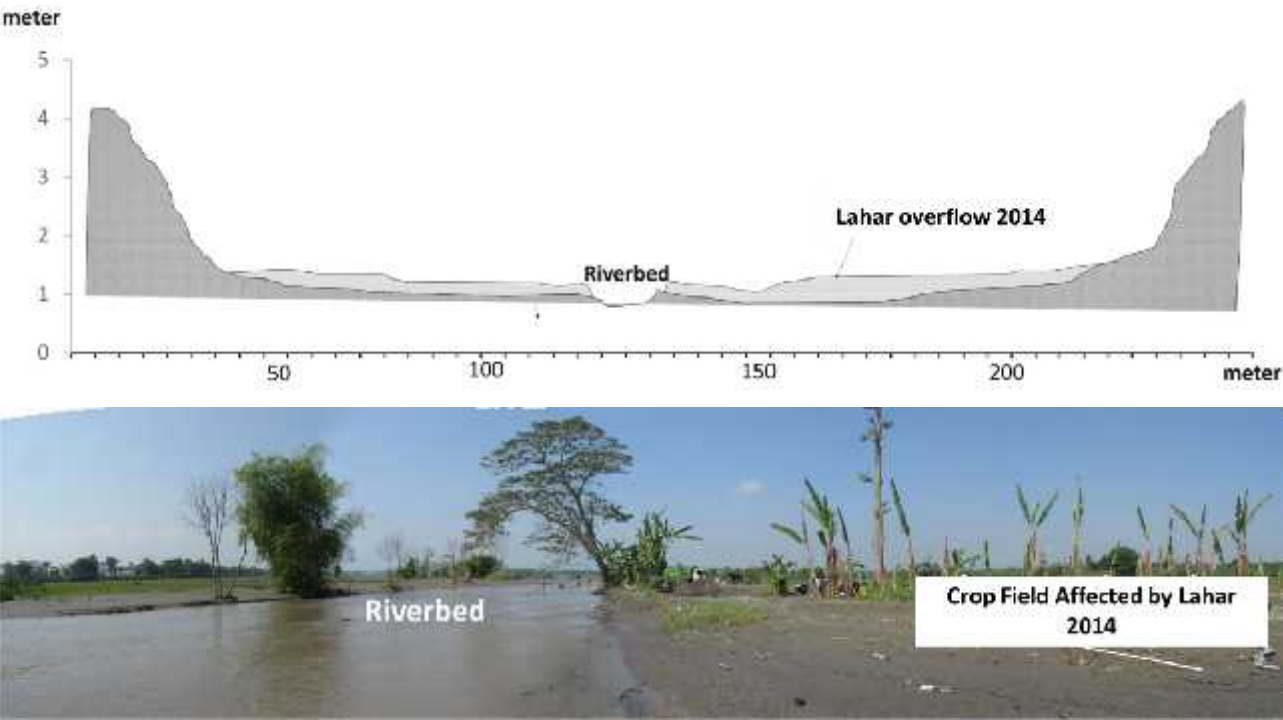
(Fig. 8). Crop land was buried with lahar thickness 0.5–1 meter (Fig. 9). Lahar deposit in Blaru different with lahar material in proximal and medial slope. Lahar overflow in the distal slope was bounded by artificial levee. The artificial levee built after lahar event 1919 to protect settlement and crop field in the vicinity. Lahar resulted aggradation in riverbed with fine-very fine sand material and it taken by mining activity (Fig. 10).

Figure 9. Cross-sectional on the distal slope at Blaru site (Red mark in Fig. 8)

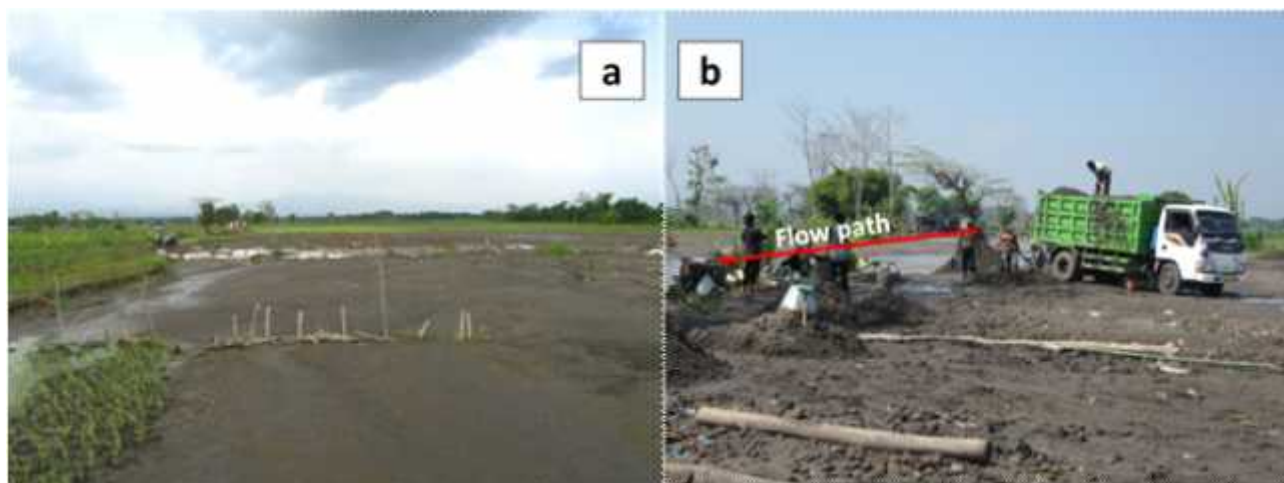
**Figure 10.** (a) Crop field inside the levee that buried by lahar and (b) mining activity in Kali Konto after lahar (Red mark in Fig. 8)
