EVALUATION OF PAVEMENT CONDITION BASED ON THE VALUE OF SURFACE DISTRESS INDEX AND PAVEMENT CONDITION INDEX ON THE ROAD SECTION OF GEDONG TATAAN - KEDONDONG, PESAWARAN

Abstract

Keywords: Road Damage, Road Quality, PCI, SDI

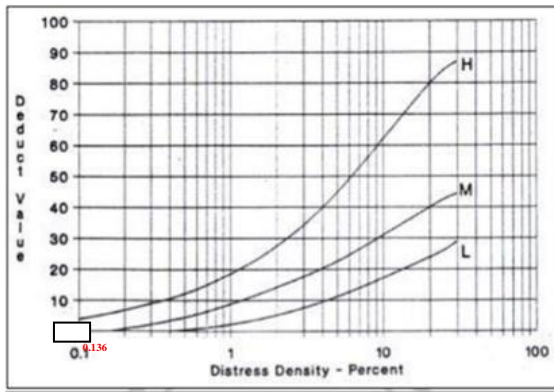
Figure 3. Deduct Value for Longitudinal Transverse Cracks

The deducted value was determined based on AASHTO (1993) as represented in Figure 2. The distress of density (<10%) expresses any minor crack at level 1. The insignificant damage was supported by value of transversal crack at value 0.136 (Figure 3). On the other hand, pothole damage on roads contributes to the greatest damage to roads with a deductive value reaching 92 as in Figure 4

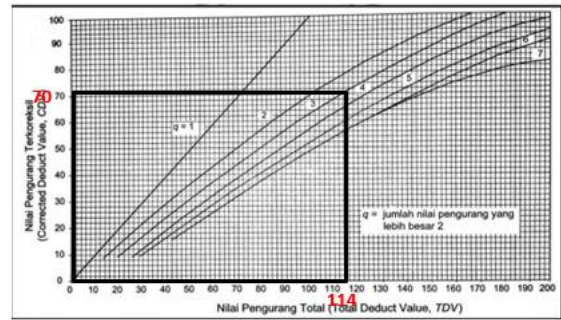
Corrected Deduct Value is obtained from the relationship curve between TDV and CDV values, for more details, see Figure 5 below.

Figure 5. Correlation Curve of Corrected Deduct Value and TDV
